**EUROPEAN
SPALLATION
SOURCE**

ESS Target Station Project Update

PRESENTED BY RIKARD LINANDER

2026-04-13

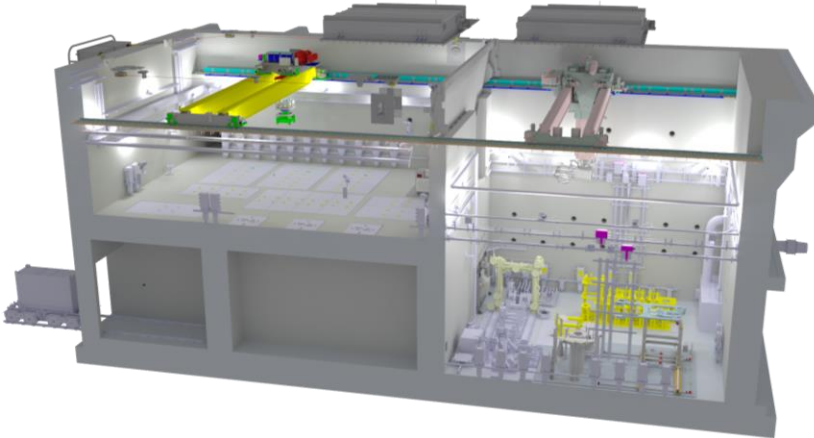
Target Safety System

- Monitors five critical operating parameters and prohibits proton beam if outside limits determined by the radiation safety analyses

Target Systems

- Tungsten target material inside a rotating, disc-shaped pressure vessel
- Helium cooling, 3 kg/s, 11 bar, 40 °C inlet/240 °C outlet

Moderators

- Provisional locations of moderators above and beneath the target wheel
- 1st MR exploits the upper space:
 - ✓ Cold, 30 mm high, liquid H₂, 17 K
 - ✓ Thermal, 30 mm high, H₂O, 300 K

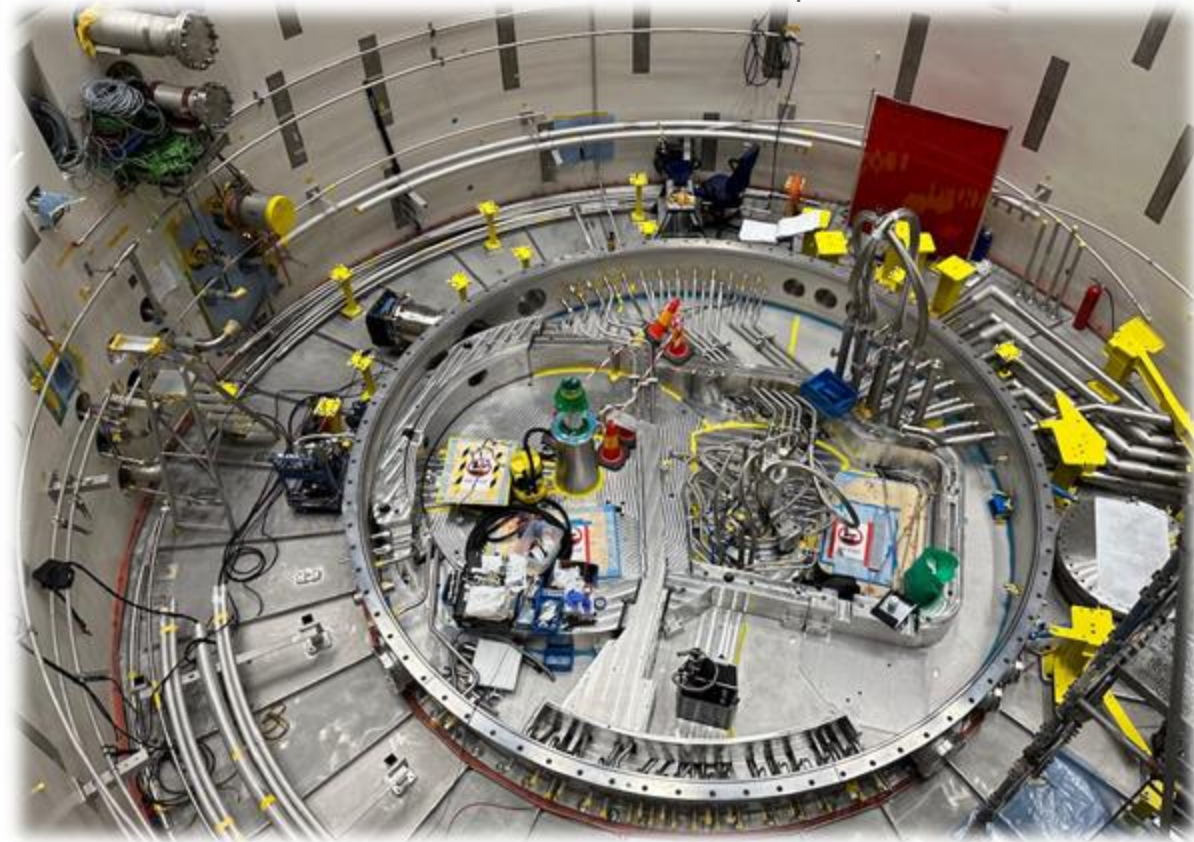
Water-cooling systems

All cooling systems feed and return pipes connected to their monolith vessel penetrations

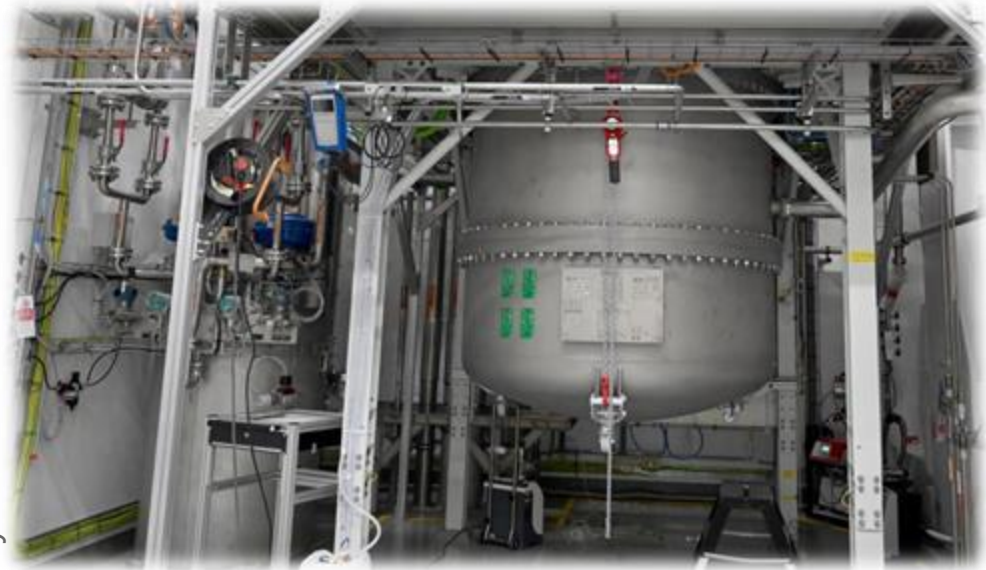
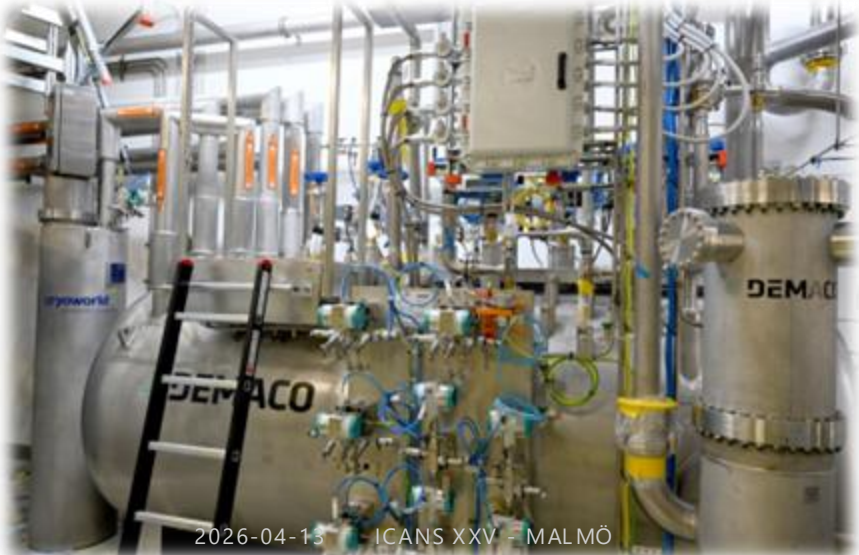
Cryogenic Moderator System Cold Box

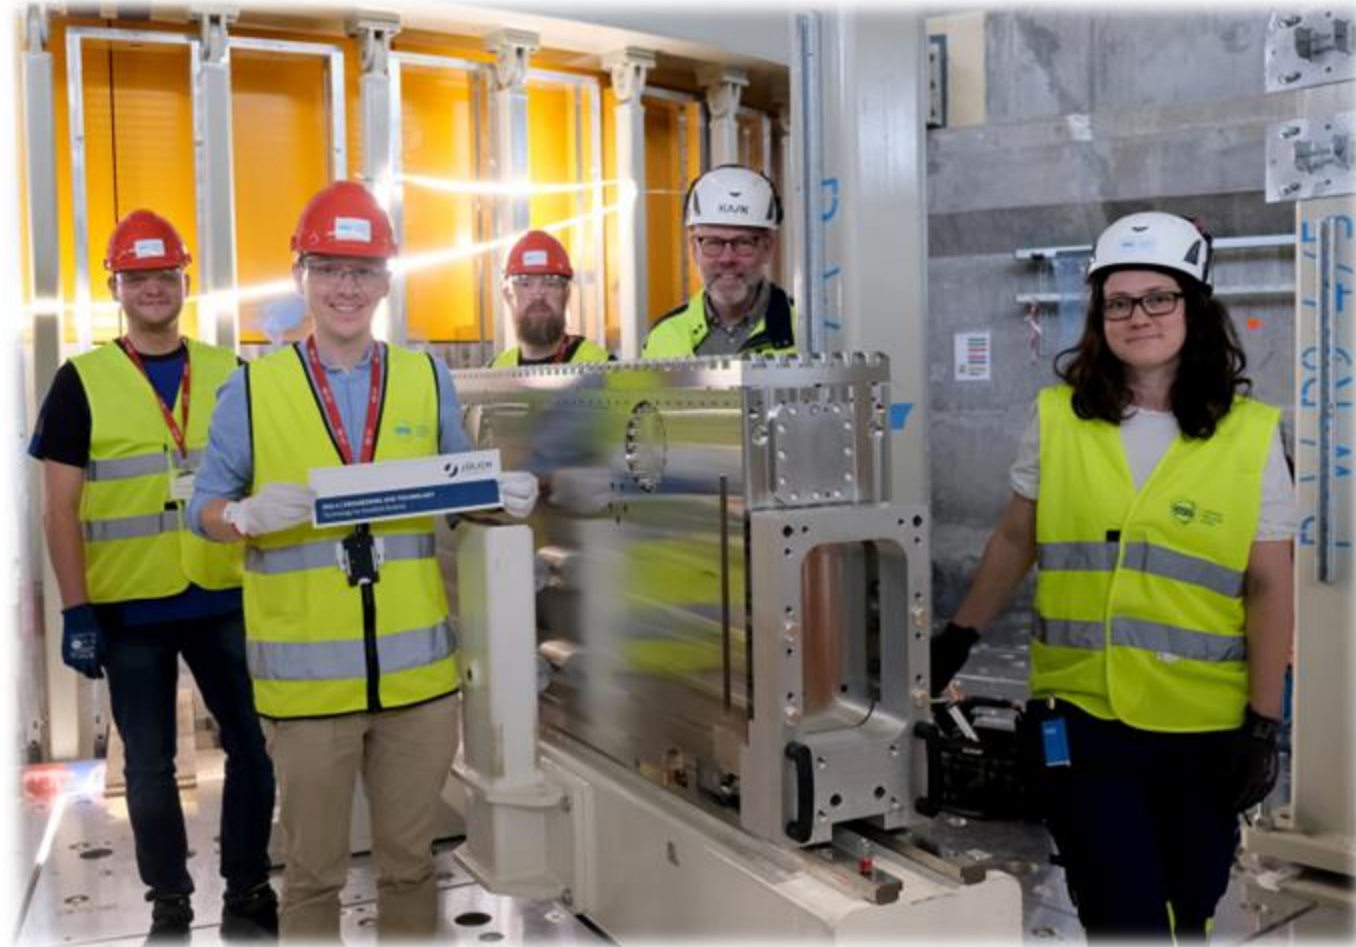
Last Neutron Beam Port Insert being installed together with in-kind partner FZJ

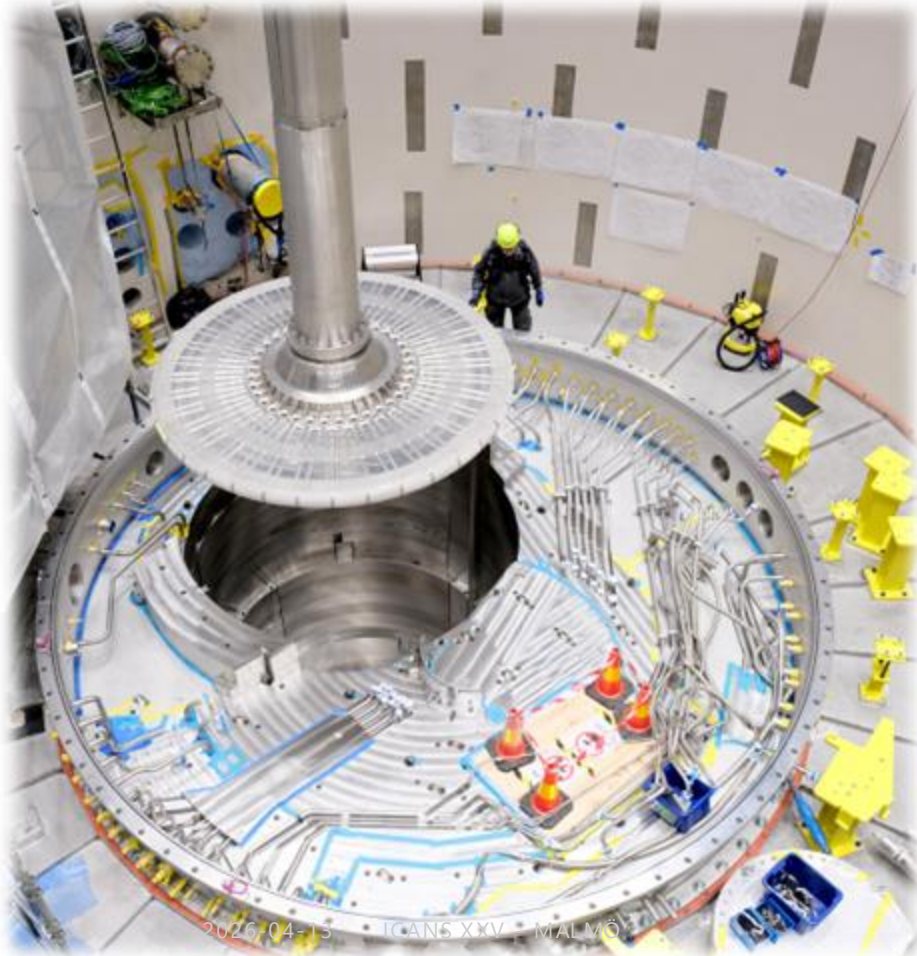
Installation of the Target Wheel

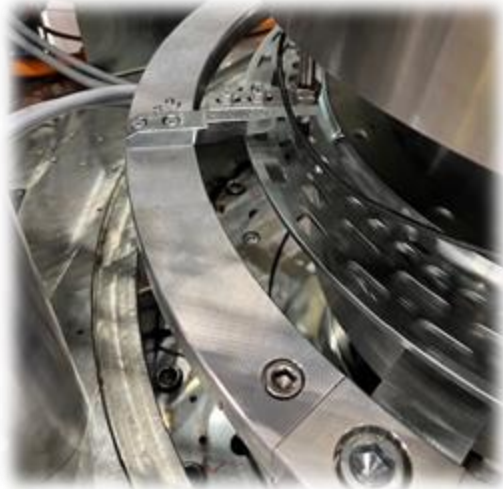
TSS target wheel rotation sensor

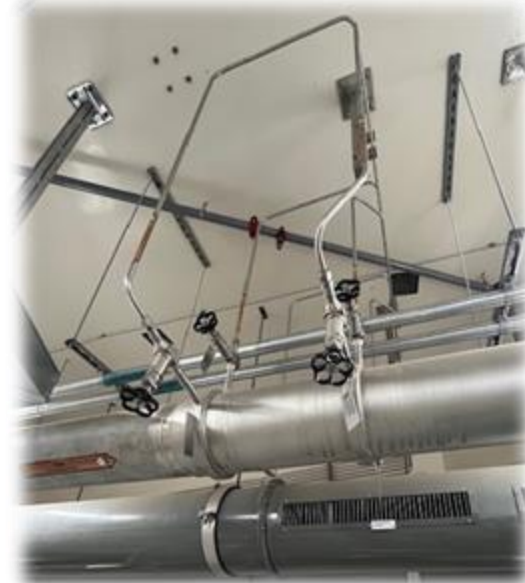
TSS venturi tube flow measurement

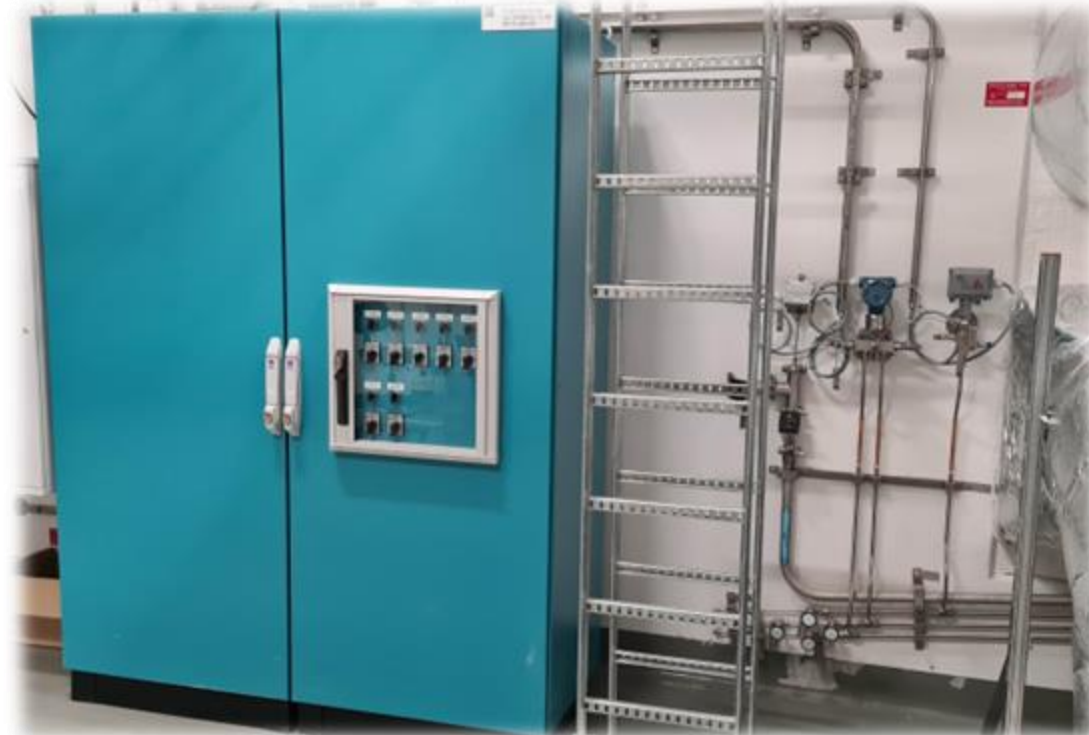
TSS field control cabinet

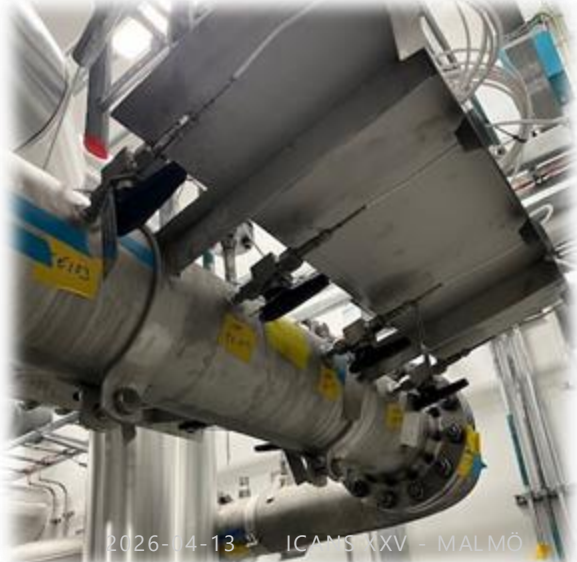
TSS helium temperature sensors

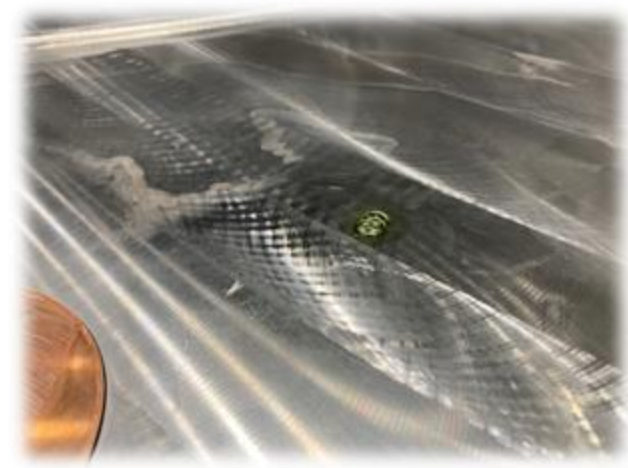
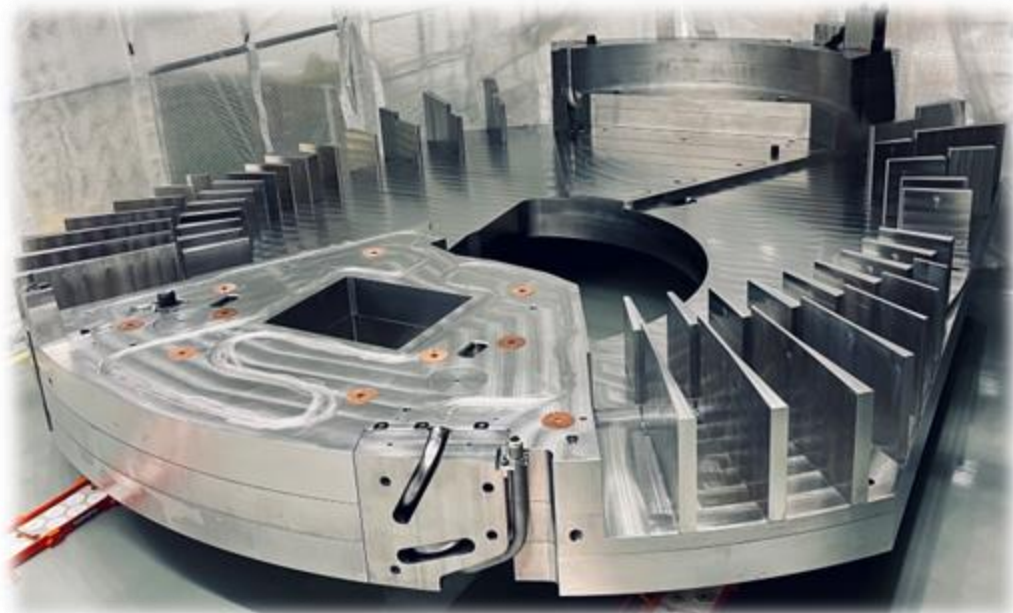
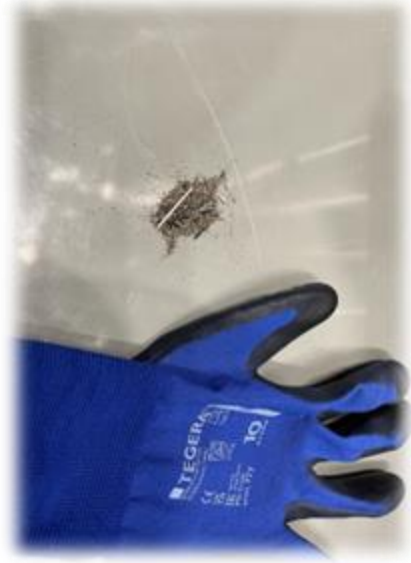
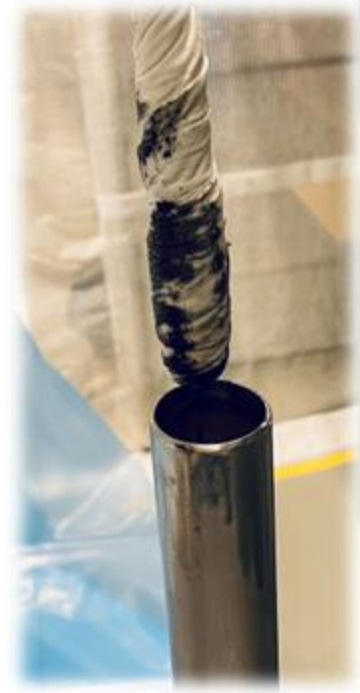
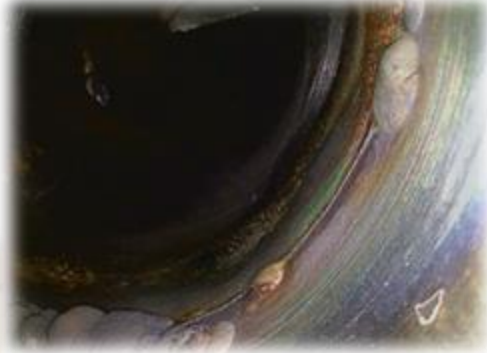
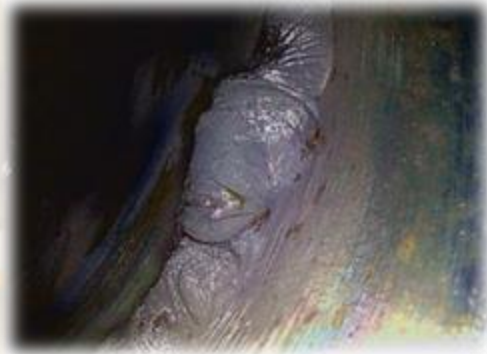
Upon receipt of several monolith inner shielding blocks, issues with both cleanliness and weld quality were found

- Already extensive Factory Acceptance Tests and inspection programmes proved insufficient. Our lesson learned was that even more intensified quality control were needed earlier in the process. (And pandemics do not help)
- The necessary remedial measures were technically straight-forward, while the schedule impact were concerning.

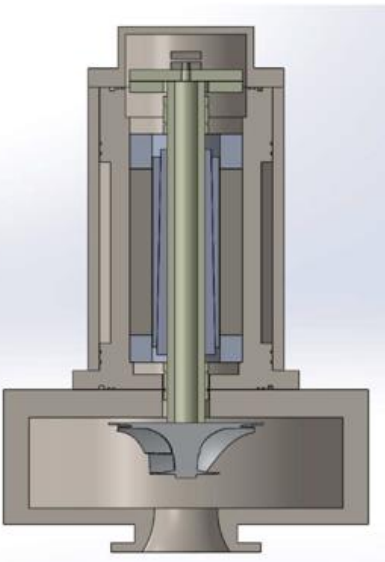
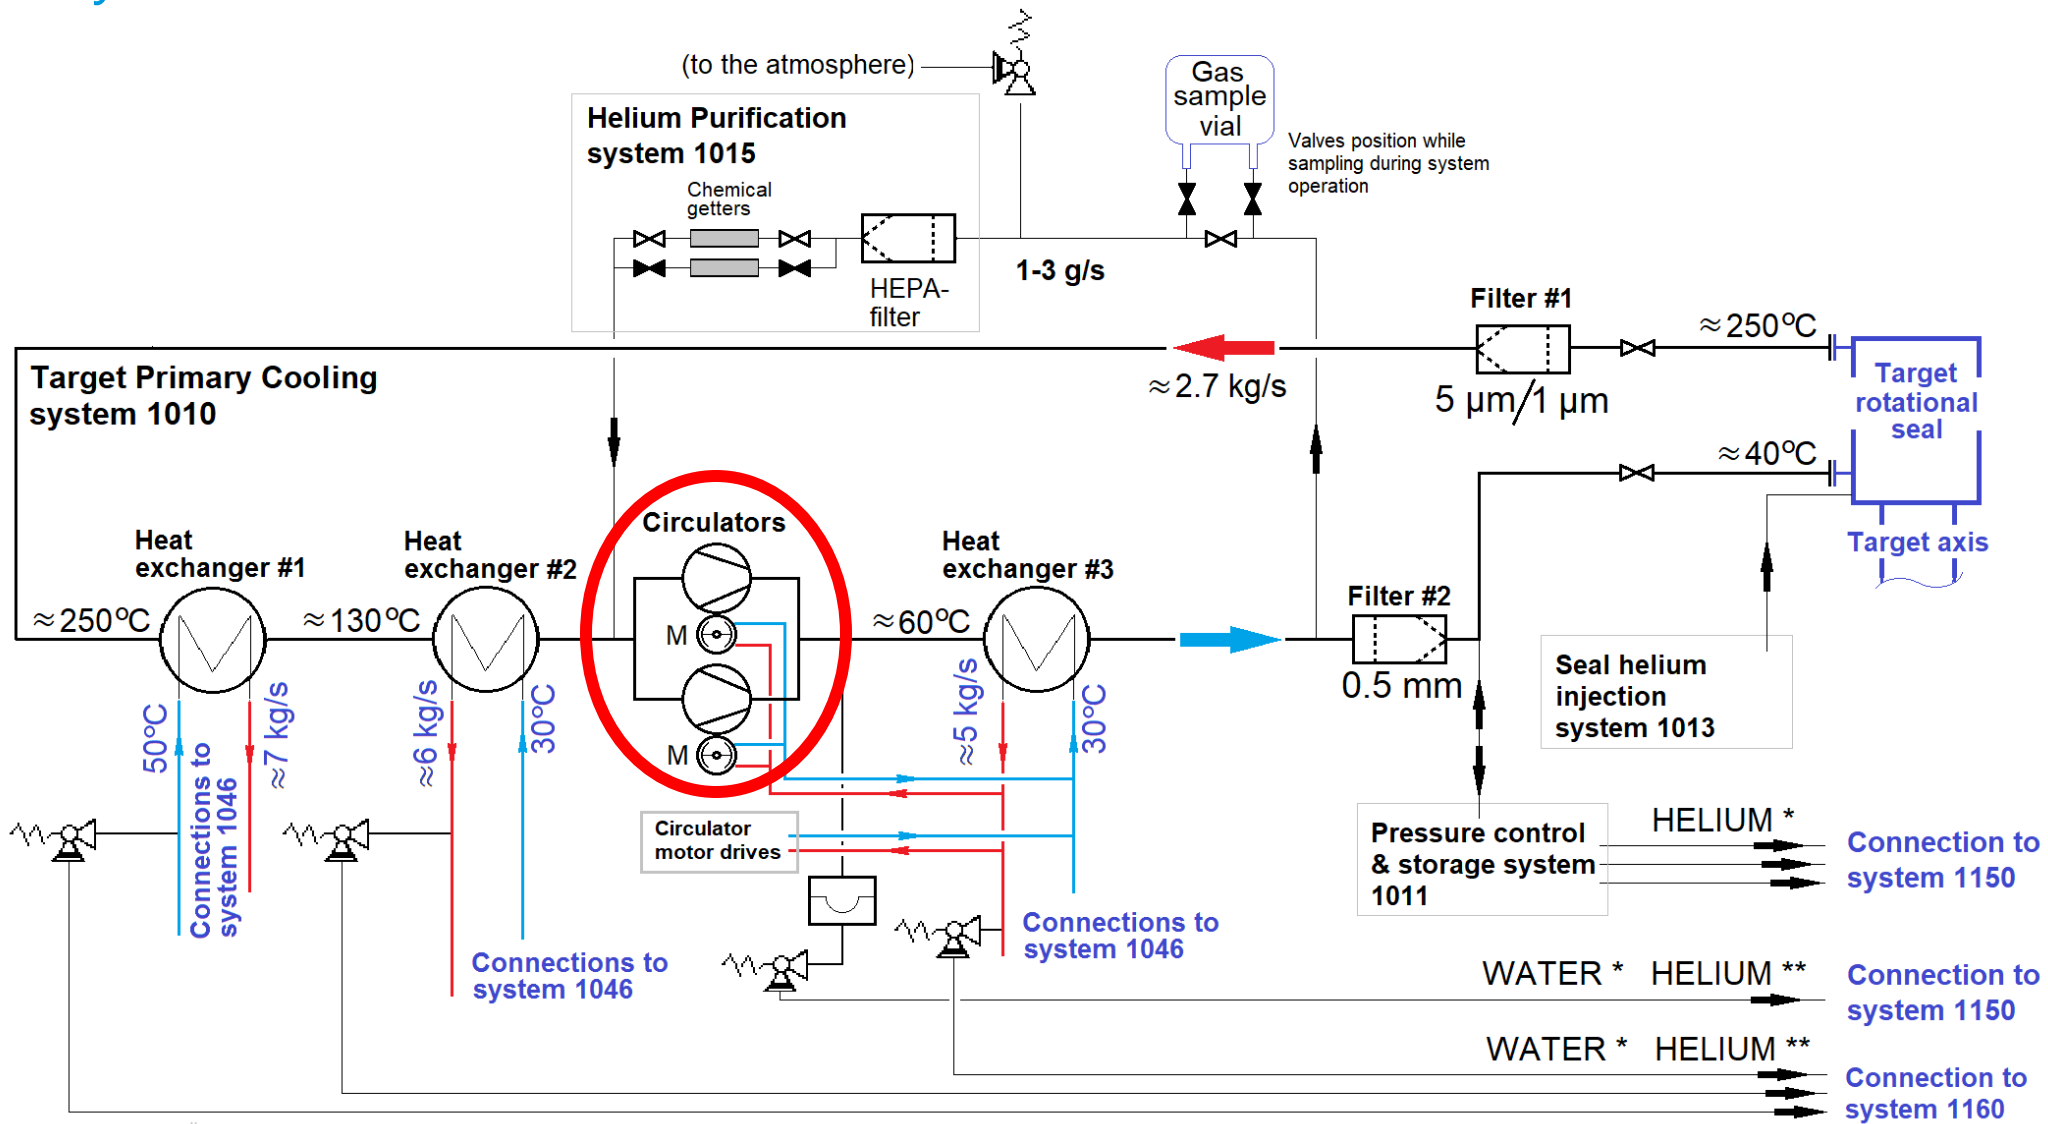
The helium system flowchart

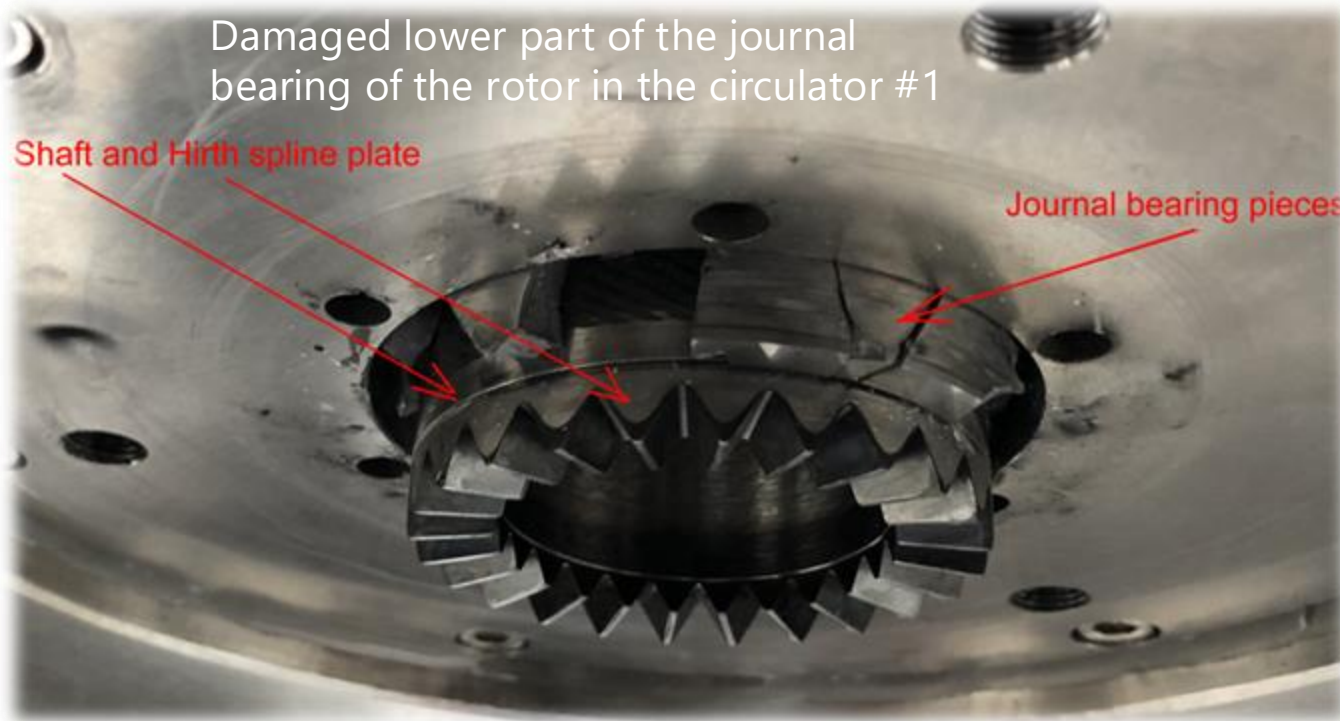
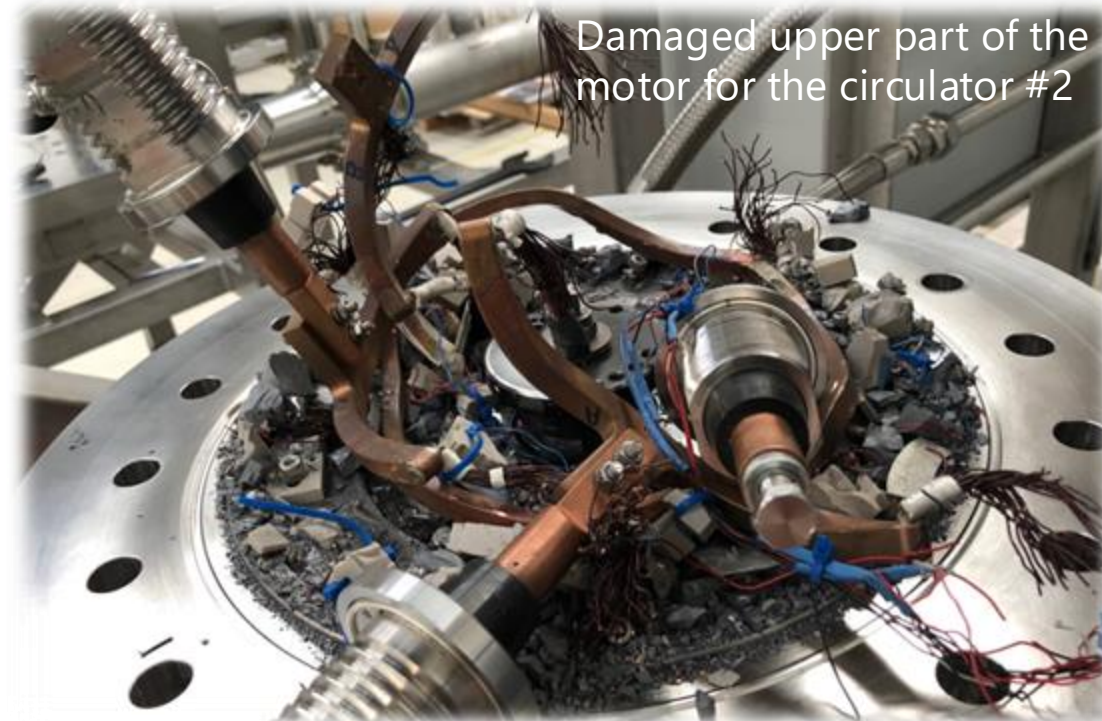
Damages to both circulator assemblies

- The most likely direct cause of the failure was debris in the test loop coupled with a non-robust design
- Our two-fold remedial action was **(A) to recover the failed turbo machines** by implementing new motors and bearings of different type and **(B) to procure and install an alternative industrial, robust screw compressor** technology
- For mitigating future risks, **both alternatives were pursued** in parallel

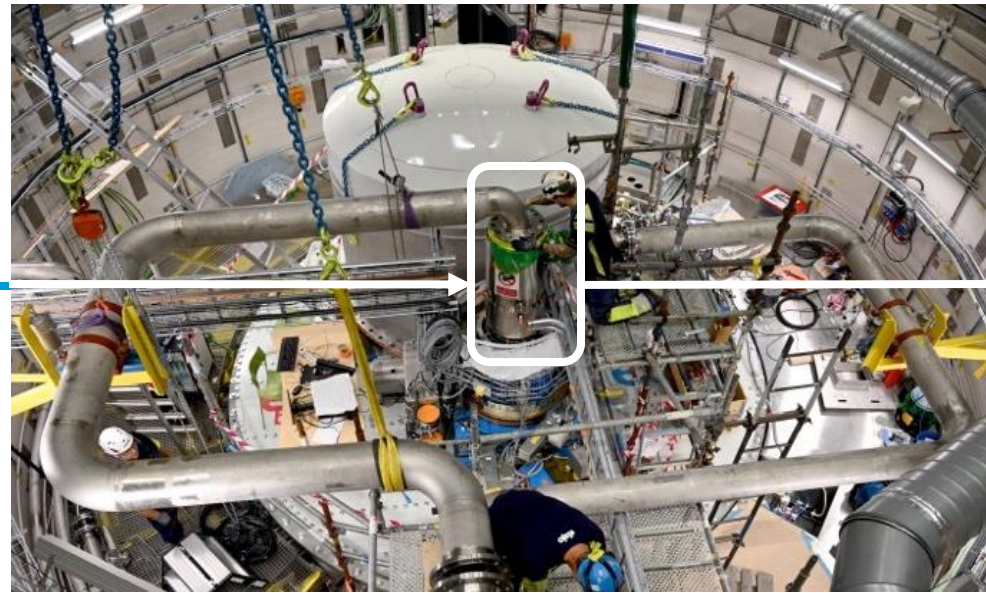
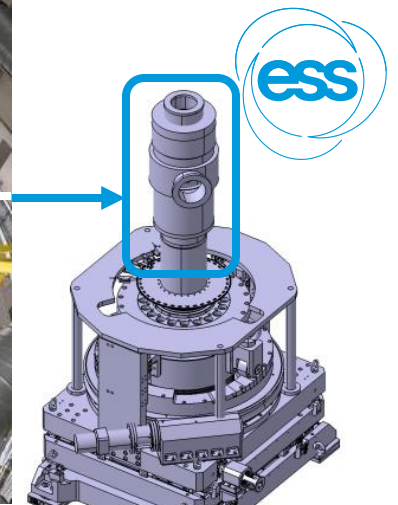
The HRU Function

- Convey helium between stationary piping and rotating target

Challenges

- Complex load pattern
 - Mechanical, static/dynamic/cyclic
 - Thermal, expansion/high temperatures
- Make possible mounting/dismounting
- Leak-tightness
 - Minimising radioactive emissions and He loss
 - Minimising internal by-pass

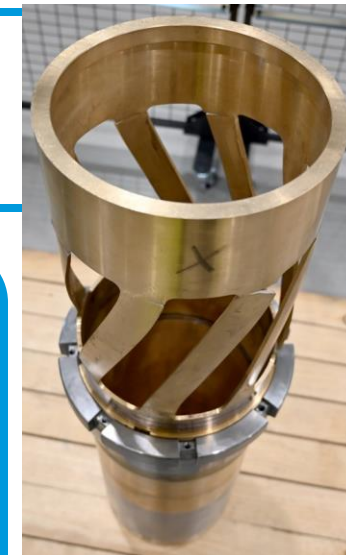
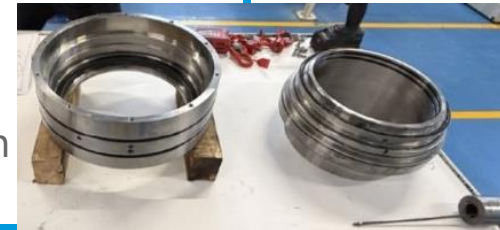
For mounting purpose

- Internal sleeve

For leak-tightness the HRU has an internal sealing cartridge

- Rubber o-rings
 - between parts without relative rotation
- Graphite rings
 - between parts with relative rotation

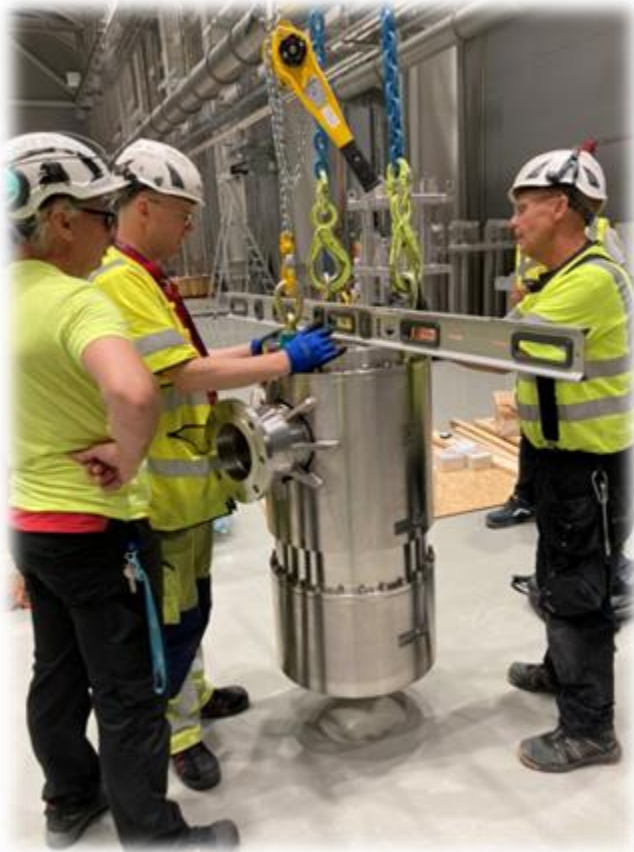
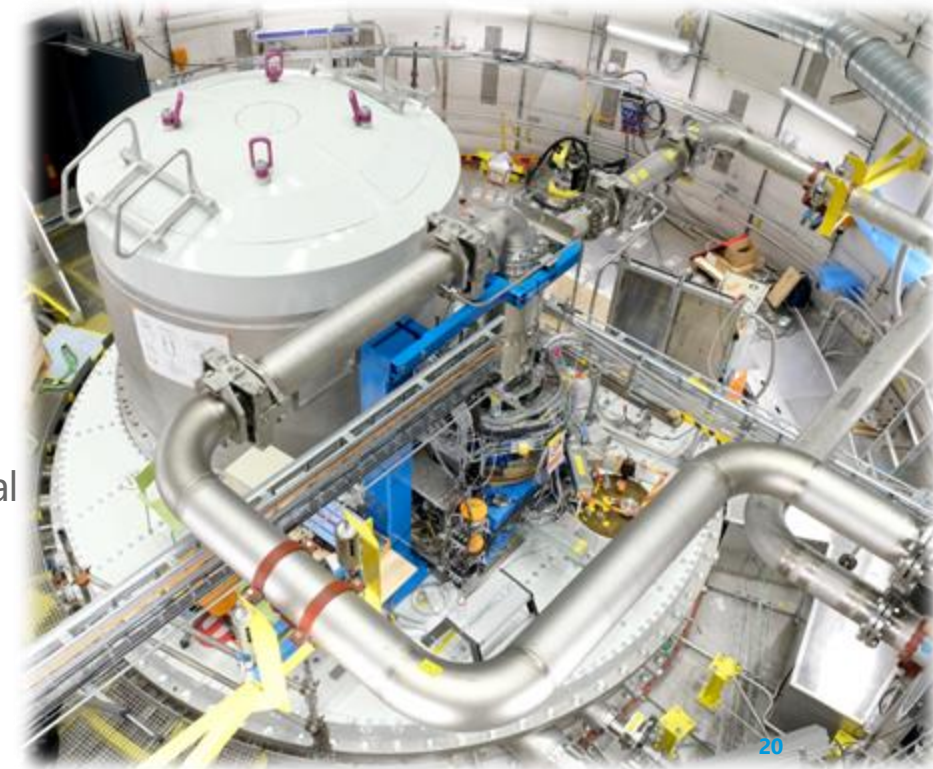
Mitigative actions for the HRU challenges are

- HRU version 1 is pursued for primary use at BoT
 - Extensive experience with the component has been gained during cold commissioning
 - Spare parts are available
 - Technicians have trained refurbishment and can get support from manufacturer
- An alternative HRU version 2 is under development
 - Includes lessons learned from HRU#1 through important design modifications
 - Can be fitted sealing cartridges with several different technologies, by modular design
 - Aim is to have this alternative available as backup at time of BoT

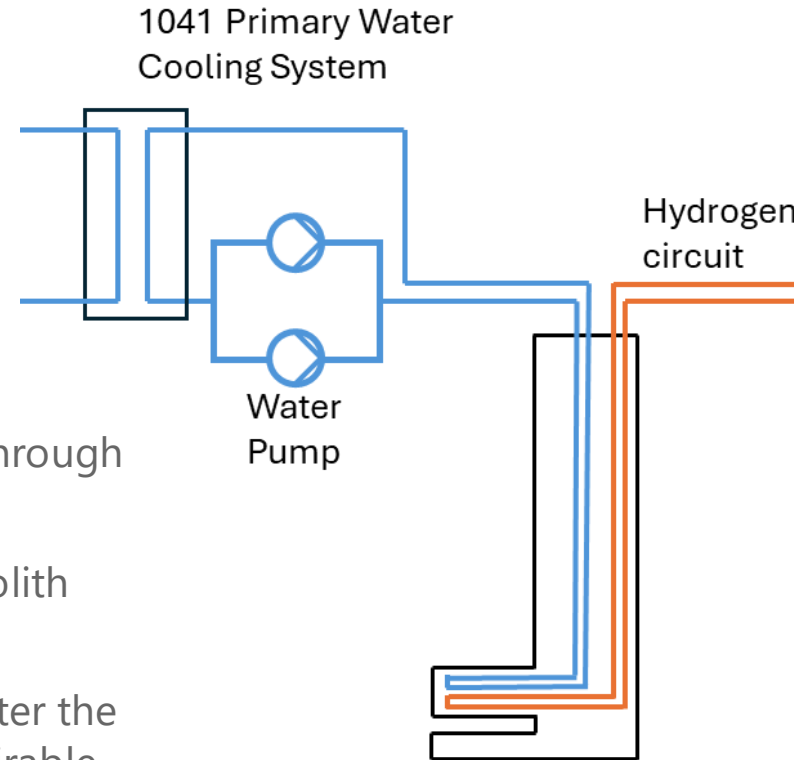
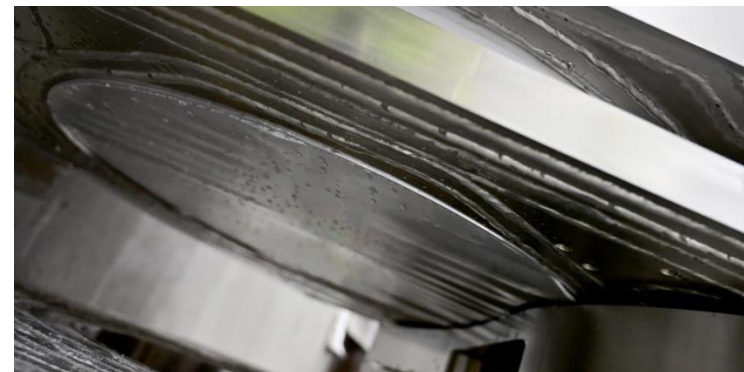
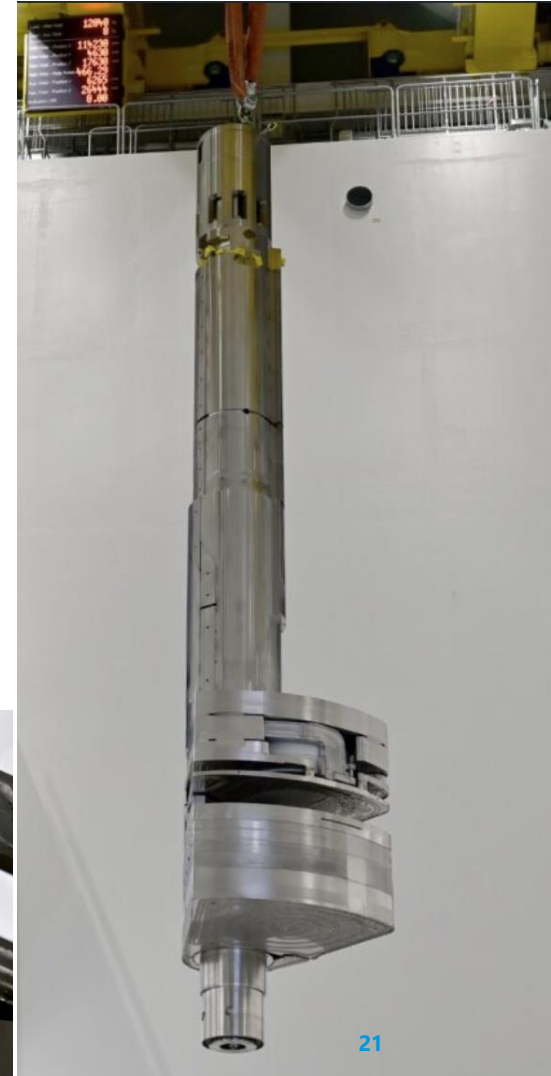
2025-11-25 – Target systems were configured for integrated system testing

- Cryogenic moderator hydrogen loop was operating normally
- Thermal moderator/pre-moderator water loop was operating normally
- Power transient caused water pump to trip and restart was delayed
- When pump restarted flow very low likely through bypass loop
- Data indicated loss of vacuum in both monolith and cryogenic pipe insulation
- After extraction of the MRP#1 a few days later the damage was obvious and deemed not repairable
- Direct cause is ice formation due to stagnant water coupled with “tight” design with the cryogen H₂
- The remedial action is to install the MRP#2, which was already in production, during second half of 2026

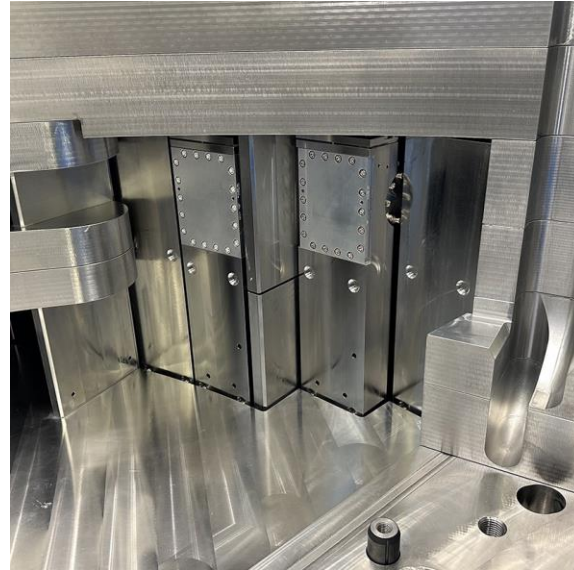
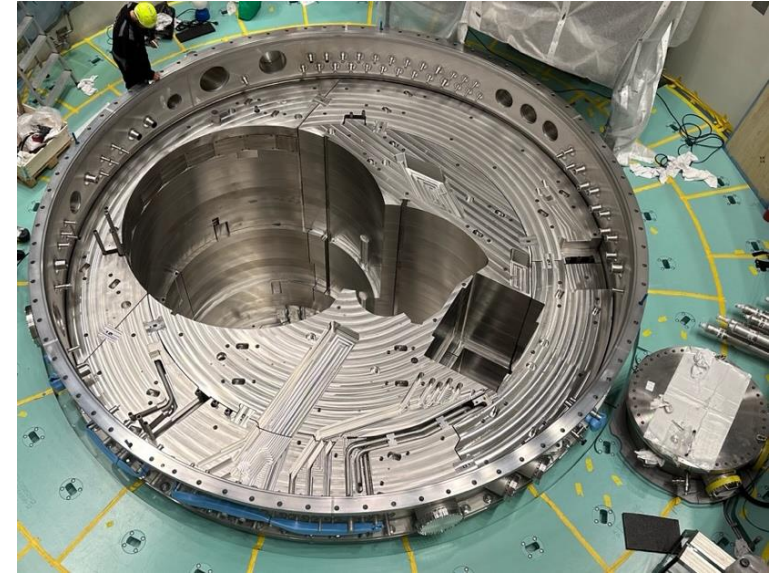
Hardware configuration

- Vacuum boundary
 - Monolith and PBW vessels
 - Connection ring
 - Neutron beam port tubes
 - Neutron beam windows
- Internals
 - Neutron beam port inserts and plugs
 - All permanent inner shielding
 - Feed pipes for water-cooled shielding

Successful achievement of monolith vacuum performance

- Leak tightness confirmed for the vacuum boundary
- No significant contamination of the monolith was found, i.e. sufficient cleanliness
- Excellent repeatability

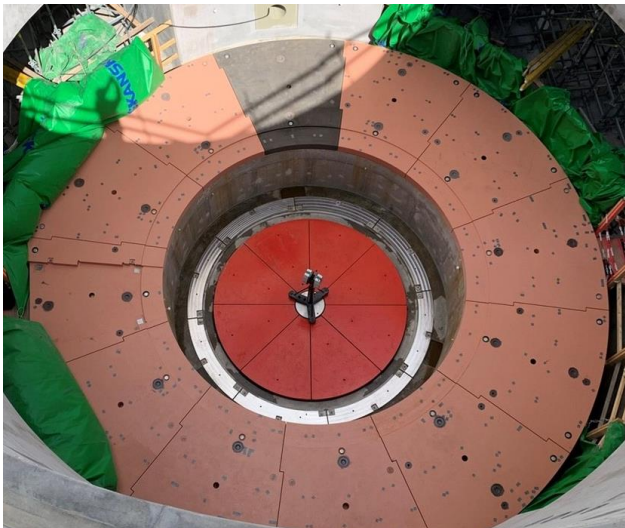
Baseplate
0.6 mm (vertical)

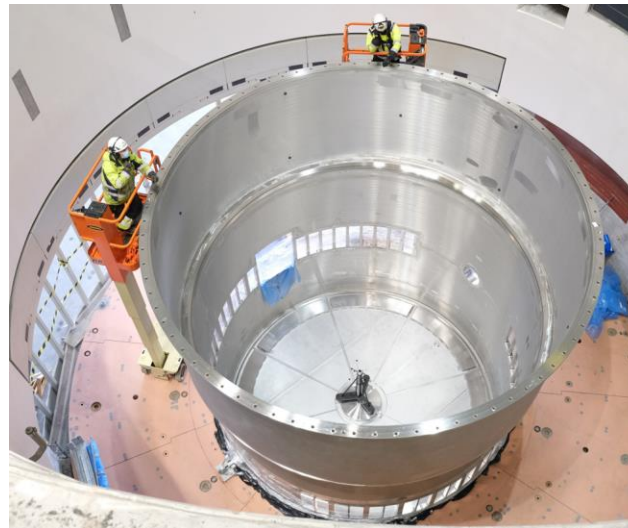
Monolith vessel
0.5 mm

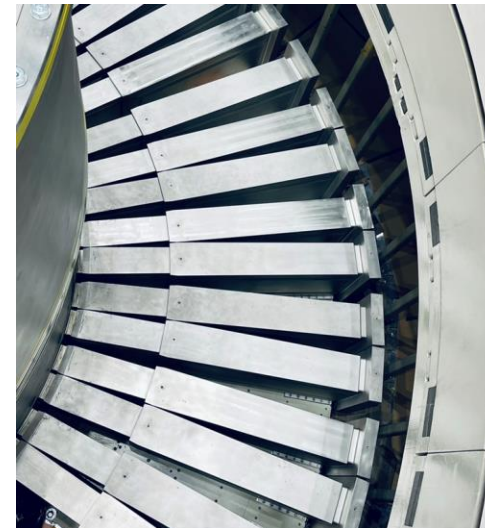
Port tubes after welding
2.9 mm (lateral)

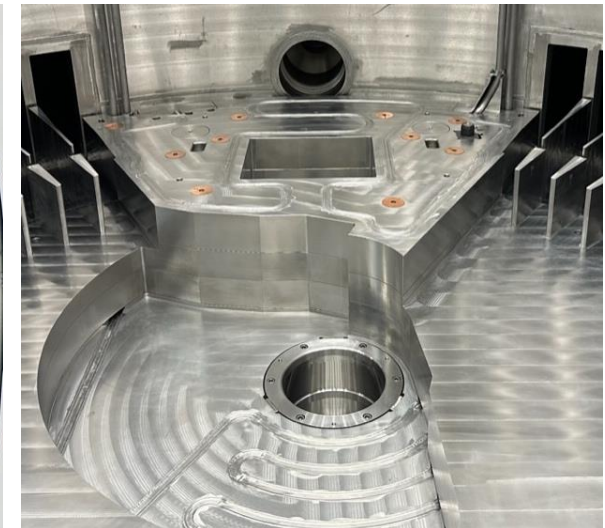
Moderator/reflector seat
0.05 mm (vertical)
0.14 mm (horizontal)

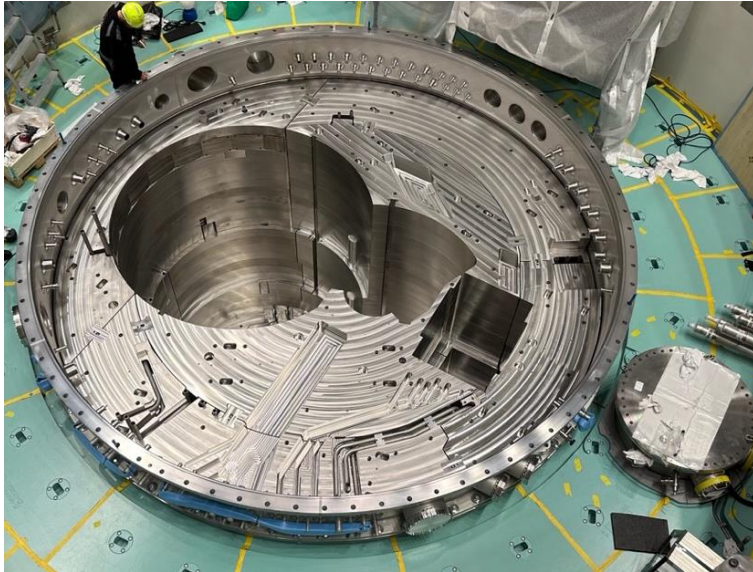
Shielding top interface with remote handling system (casks)
0.6 mm

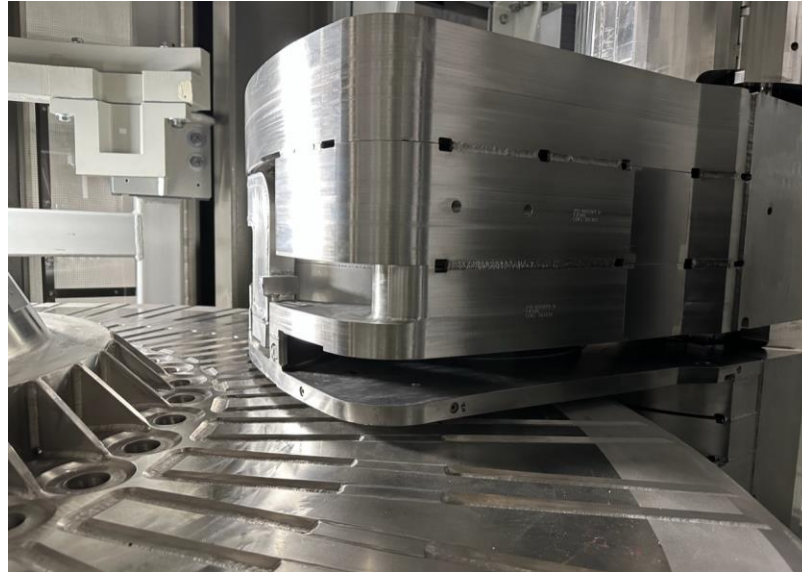
Moderator/reflector plug positioning
Expected first time install <0.5 mm
Expected replacement repeatability precision, by remote handling, <1 mm (vertical) and <2 mm (horizontal)

- Together with the expected repeatability precision for replacement of the moderator/reflector plug, i.e., ± 1 mm (vertical) and ± 2 mm (lateral), **the required precision will be accomplished!**

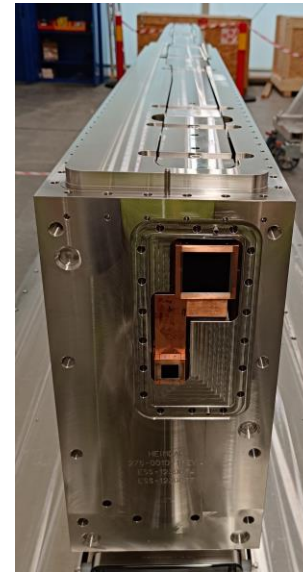
Positioning of the Neutron Beam Port Inserts
0.2 mm (vertical)
0.3 mm (lateral & axial)

- **The successful end-result**
 - All individual structures were built and installed within their specified local geometrical tolerances.
 - **Positioning deviation of the neutron beam port inserts**, as-installed, were confirmed **within a few hundred micrometres**, relative to the theoretical moderator position.
